# Manhole Inspection Summary

Manhole # S33S\_\_003MH

Insp Date: **2/12/08 3:19 PM**

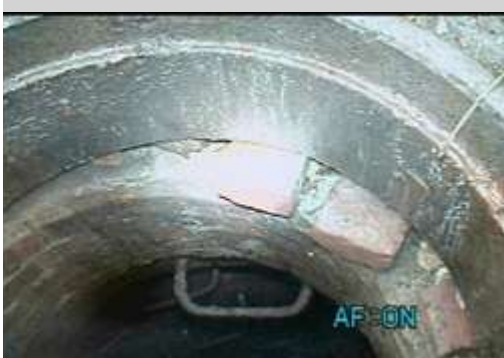
Defect 1

Offset: **2** (in.)

offset

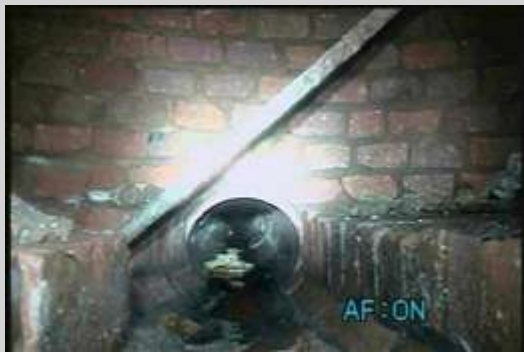
12 O'Clock Outflow

8 in. Circular Gravity Sewer  
Pipe Out @ 12 O'Clock

Deposits: ☐ None ☐ Mud ☐ Sludge ☒ **Debris** ☐ Grease

Silt Depth: **2** (in.) Deposits Extent: **Light**

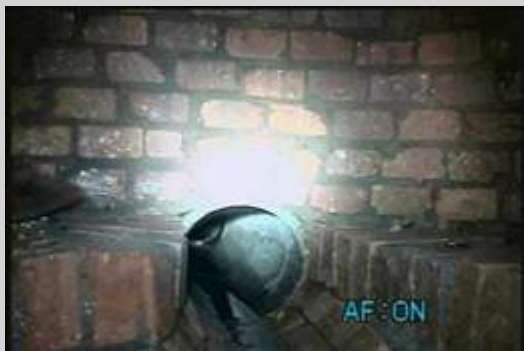
5 O'Clock Inflow

8 in. Circular Gravity Sewer  
Pipe In @ 5 O'Clock

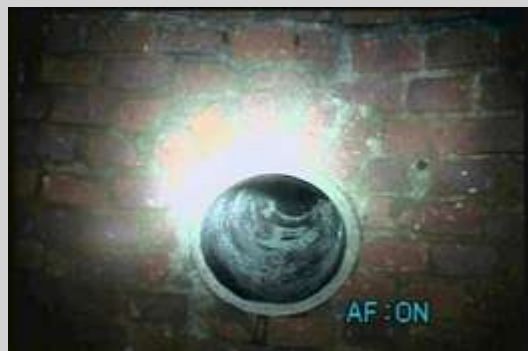
10 O'Clock Inflow

8 in. Circular Gravity Sewer

Pipe In @ 10 O'Clock

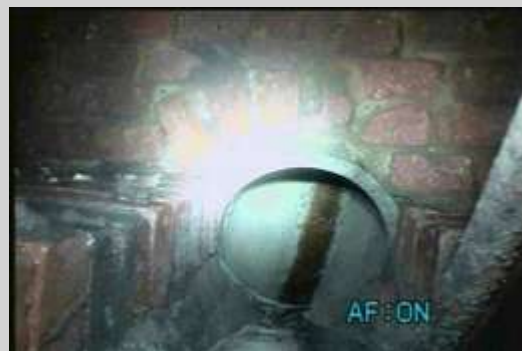
Drop In @ 10 O'Clock

Drop: **Inside** **Direct**

Inv Depth: **10.25** (ft.)

Drop Condition: **Open**
